ARCHITECTURAL HERITAGE IMPACT ASSESSMENT

Glebe House, Crumlin, County Dublin

7th June 2022

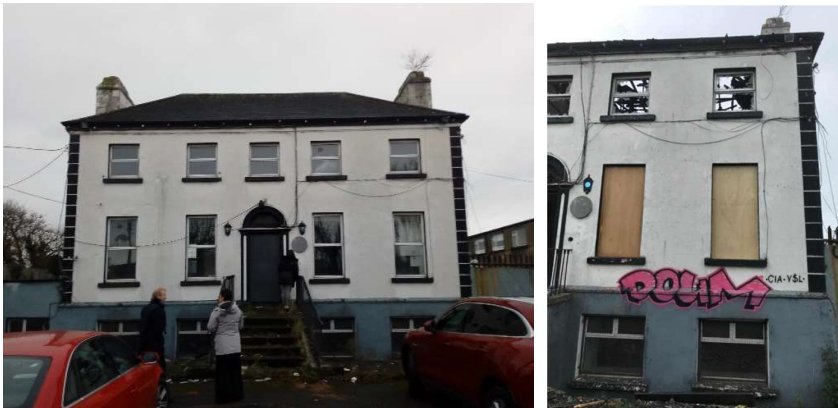
Fig 6: Front façade, before fire (L) and after fire (R)

Externally much of the original historic fabric has been removed; the badly fired damaged roof is clad in 20th century fibre cement tiles; the windows are low quality late 20th century PVC framed fenestration; all doors have been replaced with similar low quality interventions; the stacks are clad in sand cement render which has been damaged in the fire; The late 19th/early 20th century cast iron rainwater goods are in reasonably good condition.

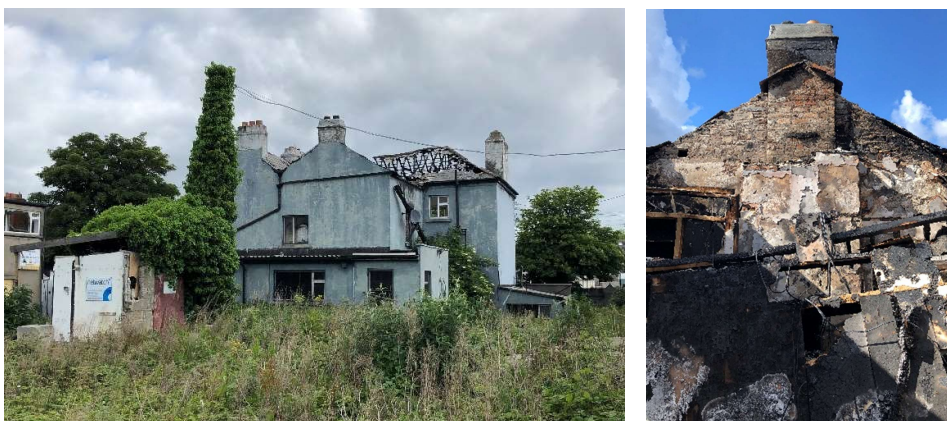
Fig 12: Views of House showing destruction to roof

Following on from our inspections of the property after the fire, it would appear that the fire started in the fireplace of kitchen/dining area at first floor level to the rear return. This room also contained a mezzanine level which has been completely destroyed. From here the fire appears to have travelled through the stairway to the first floor level to the main body of the building. This has resulted in damage to the stairway, first floor level and the roof areas.

- All roof structures have been completely destroyed. Whilst some rafters remain in position, they are unstable and should be removed. It should be noted that the roof finishes and structure are not original building fabric.

- The damage to the roof includes breaking of the fibre cement slates which may be asbestos containing. The slates are not original building fabric.
- All timber stud work at first floor level has been compromised as a result of the fire.

- All studwork to the first floor level has been severely damaged and will require replacement.
- The non-original T&G floor boards to the first floor level will require replacement, however it may be possible to salvage the first floor joists.

- The main stairs from upper ground to first floor level has been extensively damaged and will require replacement. This stair is not original building fabric.

- There is damage noted to the floor joists of the kitchen/dining area, particularly adjacent to the fireplace which appears to be the source of the fire. The floor joists will require replacement. The existing joists do not appear to be original building fabric.
- The internal plaster to the kitchen/dining area has de-bonded from the masonry substrate.

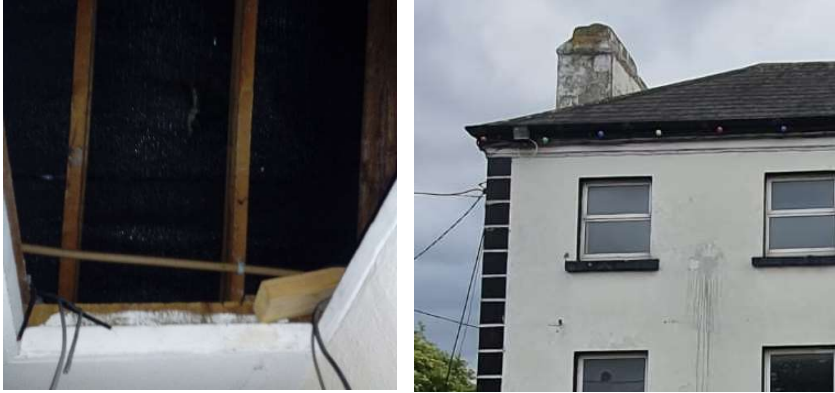
Fig.31: Internal & external view of Glebe House roof fabric before fire .

All roof structures have been completely destroyed. Whilst some rafters remain in position, they are unstable and should be removed. It should be noted that the roof finishes and structure are not original building fabric. The external slates were fibre cement sitting on a modern bitumen based roofing felt on modern timber rafters. The roof was almost totally replaced sometime in the relatively recent past. There is no significant historic roof fabric remaining.

A new timber roof structure will be constructed to match the pitch and design of the roof that was burnt in the fire of April 2022. Details of the proposed roof structure are detailed on Conservation Engineer's drawing S.103 (Rev DR01).

We will select a replacement natural slate which compliments the historic house in terms of quality, appearance and performance. The remnants of the existing roofing felt will be removed and replaced with breathable alternative. To give reasonable life expectancy to the new roof the European Standard recommendation in the choice of slating nails will be followed, ie, use aluminium, copper or silicon-bronze nails not zinc plated steel nails. All metal flashings and their supporting structures should also be checked and replaced where decayed. A roof void will be ventilated by using ventilators on the ridge or by breaking into disused chimney flues the accumulation of stagnant pockets of humid warm air can be avoided and prevent outbreaks of fungal attack. We will carefully select products appropriate to each project, such as flush vent slates on partially concealed eaves or ridge vents which will not detract from the general appearance of the finished roof. The details at gable, eaves and ridge will all be drawn or described in words to ensure the historic authenticity of the building is maintained. This description will include, where required, the colouring of mortar for setting the ridge so as to tone in with slates.

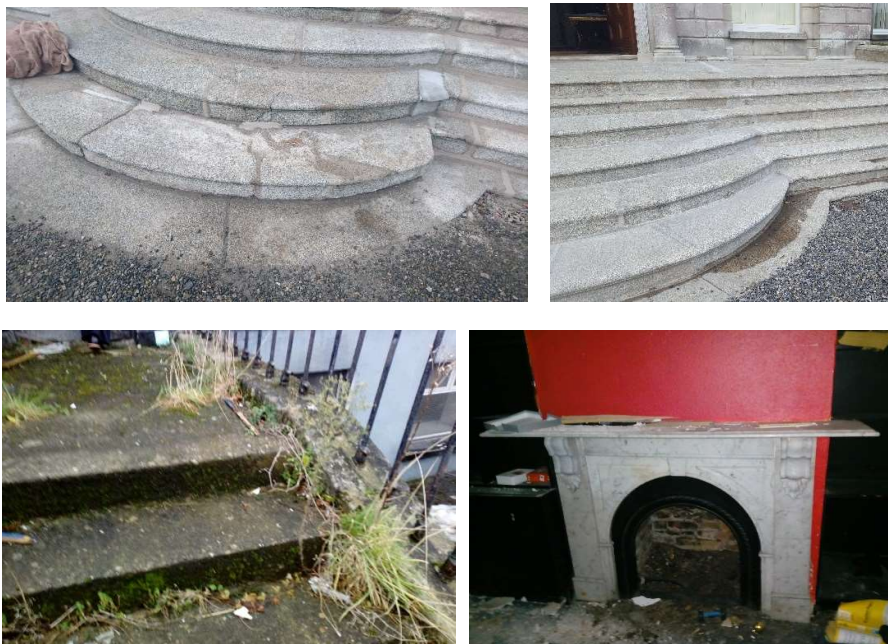
Fig.35: Before (TL) and After (TR) images of step repair at Charleville House. (BL) Existing external steps at Glebe House; (BR) existing marble fire piece at Glebe House

The Glebe House is not a very grand house and use of expensive dressed stone is limited. As noted above there is an existing coat of cementitious render to the external entrance stairs. This to be removed to expose the stonework underneath. This underlying masonry will be repointed as required with lime mortar. The work is to be carried out by experienced persons under close supervision by the conservation architect. The removal of the render is to be carried out by the use of hand tools only. The use of pneumatic power tools will not be permitted at any time. A recent example of similar repair work carried out to steps of Charleville House, Co. Wicklow, under the direction of Mullarkey Pedersen Architects, is shown below. The before photo on the left shows cracking and damage as the consequence of the construction of an iron entrance canopy, which was later removed. The picture on the right shows the renovated steps.

Where damaged the dressed stone will be repaired with indents using a stone chosen to match the existing. The stone required will be sourced from quarries to provide an accurate match to the existing stone and we will ensure the quarry can supply the quantity required to complete the works. The stone will be stored in clean, dry conditions. It will be stored clear of the ground to prevent the leaching of soil salts and moisture staining. The pallets will be covered using polythene sheeting to protect the stone from wet conditions. This will be placed over the more normal coverings such as straw or hessian. Approval of the stone will be agreed with the Planning Authority prior to work commencing. Stone indent replacements will be cut exactly to size off site, allowing for a perfect match to the measurements of existing joints. All replacement stones will be same thickness as the original. The new stone will be hand finished in-situ. The stone faces of the indent recess will be moistened prior to bedding and the mortar will be laid on the faces of the stonework. The stone is then to be firmly bedded in the mortar. During placement, no damage is to be caused to the edges or face of the new or existing stone.

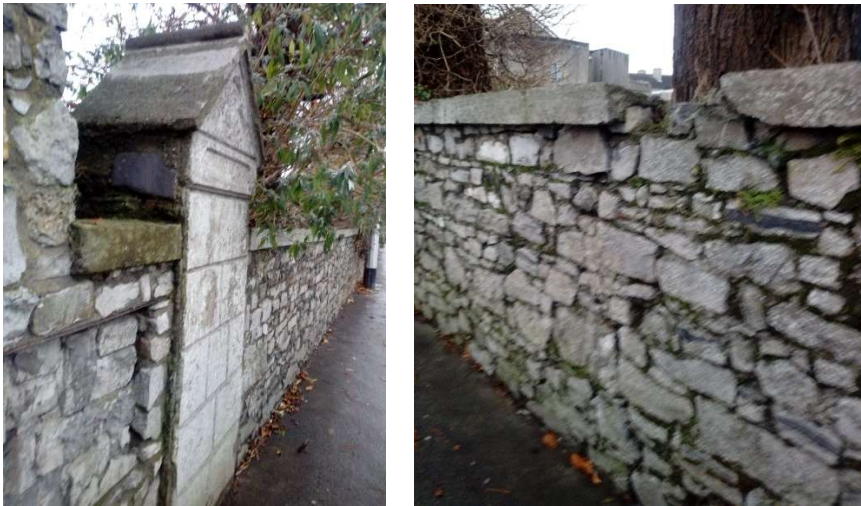
Fig.38: Detail view of existing boundary wall on St Agnes' Road to be lowered & retained

We note that the pillar shown above in *Fig. 37* is not dressed stone but rather masonry rather crudely faced with a cement render dressed to look like ashlar.

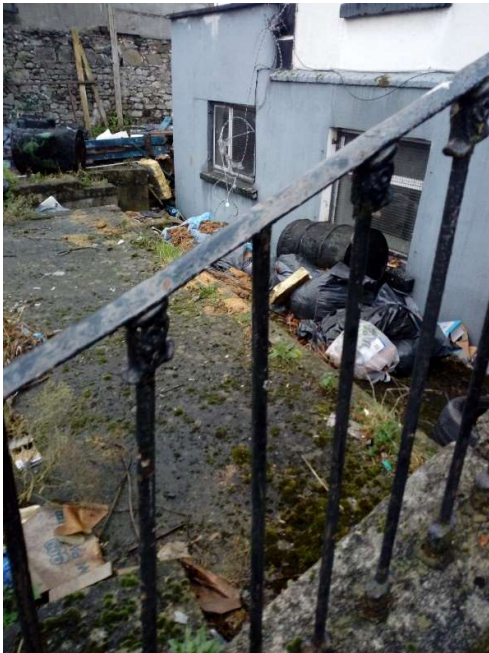
The only historic ironwork at Glebe House are the flanking balustrades to the external entrance stairs. The railings are in reasonable condition and it is our intention to retain as much as possible of the original work and only replace details that are beyond practical repair. Where repair is required we will ensure reproduction the style and working techniques of the original and take all possible steps to protect ironwork from future corrosion. We will arrest mild corrosion; all oxide and scaling will first be cleaned off by means of shot-blasting in a specialist workshop. Those sections which are removable will therefore be dismantled and taken to this workshop. In localised areas the surface will be pecked and wire-brushed by hand. The surface will then be pickled using phosphoric acid, followed by paint priming other durable protective coating. If corrosion is really bad then replacement in whole or in part is the only course of repair. Amber Justice Partnership notes that wrought iron fractures only if it is continually subject to changing stresses, but cast-iron fractures very easily where this has occurred and, provided the object is non-structural, it may be possible to glue it back together using epoxy resins. If the component is structural it may be possible to

carry the load in some other way and then effect a repair using epoxy resins. If this is impossible then a new casting is the only remedy. Paint is central to the long-term maintenance strategy. Paint provides a vital protective layer over external metalwork and railings, preventing weathering and water ingress and helping to avoid fabric deterioration. We propose the use of a two-pack epoxy paint which will provide protection for up to 25 years.
