ARBORICULTURAL ASSESSMENT & IMPACT REPORT

GLEBE HOUSE
CRUMLIN VILLAGE
DUBLIN 12

TGLE002

11/04/22

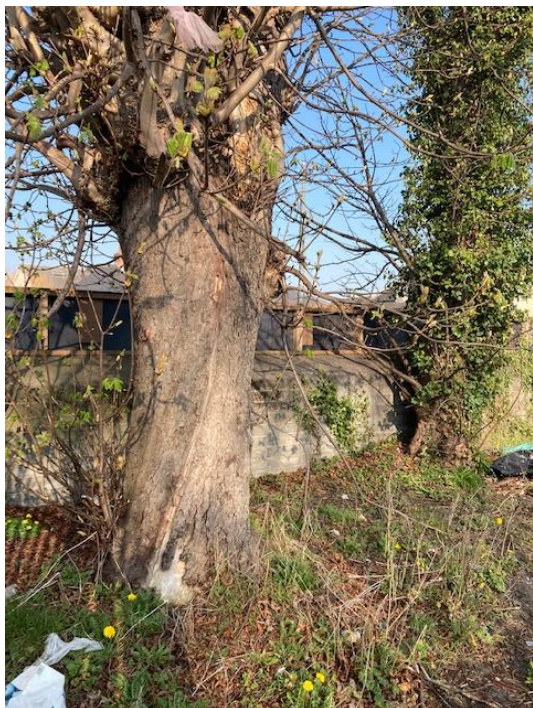
The site which contains a historic property and industrial buildings contains four mature trees on its northern boundary (3 x Horse chestnut, 1 x sycamore) with one additional mature sycamore tree on the western boundary. All the trees have been pollarded / topped in the past leading to the development of extensive decay in most instances and strong vertical regrowth at pruning points. There are also signs of bark damage to one tree #1575 (image 2).

Image 2. Bark damage to base of tree #1575

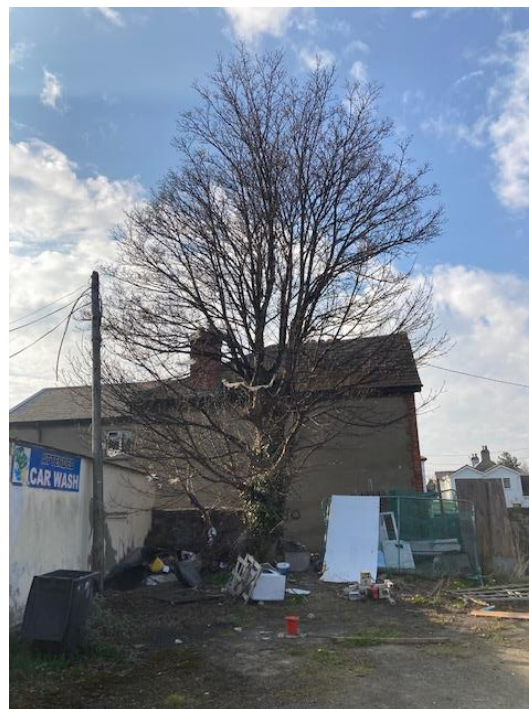
which are difficult to identify with any degree of certainty. It requires that future management actions are mindful of these factors and inevitably requires the trees to be periodically topped / pollarded to reduce hazardous structural weaknesses developing. Tree #1574 (image 3) which is located on the western boundary has extensive areas of decay and is also damaging the boundary wall.

Image 3. Sycamore #1574 on western boundary

The proposed development will directly impact on one mature sycamore tree (#1574) which is in conflict with the access road.

The loss of the two mature trees is not considered to be significant. It is very likely that both trees would require removal based on their impact on the western boundary wall (#1574) and potentially hazardous condition adjacent to a public road (#1578) in the near future.

Tag number	Species	Age Class	Vigour	Comments	Preliminary Recommendations	Category	Long-term potential (years)	Dbh mm	Height m	Spread m N, E, S, W	Clear Stem m
1574	Sycamore Acer pseudoplatanus	Mature	Good	Located on western boundary and abutting boundary wall. A large cavity at 4m to north beneath point of crown topping. A very large pruning cut to trunk at 3m to south with associated decay. The decay at both points could be connected. Long-term potential limited as a result. The retention of this tree would require continual crown management and an investigation of potential decay within trunk.	Reduce canopy by 3m	C2	10-15	12	750	3,4,4,3	1.75E
1575	Horse chestnut Aesculus hippocastanum	Mature	Good	Located on northern boundary. Tarmac road surface at base to south may restrict root development in this direction. Extensive bark damage at base. Large limb removal at 2.15m to south with localised decay. Topped at 3.25m with resulting strong multiple re-growths.	Remove larger re-growths.	C2	10-15	11	800	3,2,4,4	2N
