ARCHITECTURAL HERITAGE IMPACT ASSESSMENT

Glebe House, Crumlin, County Dublin

7th June 2022

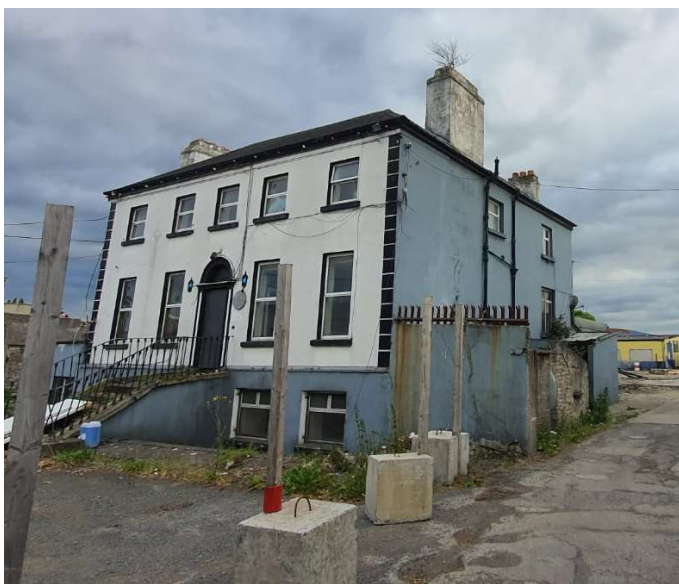
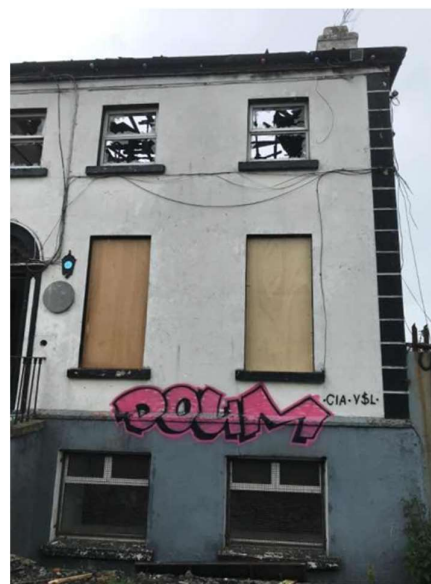
Glebe House, Crumlin before (left) and after (right) fire of April 2022

Following on from our inspections of the property after the fire, it would appear that the fire started in the fireplace of kitchen/dining area at first floor level to the rear return. This room also contained a mezzanine level which has been completely destroyed. From here the fire appears to have travelled through the stairway to the first floor level to the main body of the building. This has resulted in damage to the stairway, first floor level and the roof areas.

In summary, the extent of the fire damage includes:

- All roof structures have been completely destroyed. Whilst some rafters remain in position, they are unstable and should be removed. It should be noted that the roof finishes and structure are not original building fabric.

- The damage to the roof includes breaking of the fibre cement slates which may be asbestos containing. The slates are not original building fabric.
- All timber stud work at first floor level has been compromised as a result of the fire.

- All studwork to the first floor level has been severely damaged and will require replacement.
- The non-original T&G floor boards to the first floor level will require replacement, however it may be possible to salvage the first floor joists.

- The main stairs from upper ground to first floor level has been extensively damaged and will require replacement. This stair is not original building fabric.

The repair of fire damaged elements (following a fire 21st April 2022) and the refurbishment of Glebe House, a protected structure, into two apartments, one number 2 bed unit at lower ground floor and one number 3 bed unit at upper ground and first floor;

- Repair of fire damaged elements including the replacement of all roof coverings and structure, replacement of all first floor timber stud walls, replacement of first floor rear return joists, replacement/repair of floor joists at first floor level, replacement of internal render to kitchen/dining area in rear return building and replacement/repair of stair from upper ground to first floor level,

A new timber roof structure will be constructed to match the pitch and design of the roof that was burnt in the fire of April 2022. Details of the proposed roof structure are detailed on Conservation Engineer's drawing S.103 (Rev DR01).

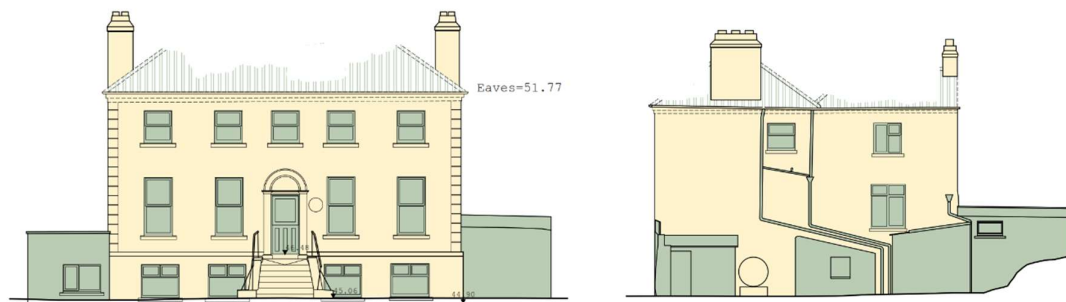
Externally much of the original historic fabric has been removed; the badly fired damaged roof is clad in 20th century fibre cement tiles; the windows are low quality late 20th century PVC framed fenestration; all doors have been replaced with similar low quality interventions; the stacks are clad in sand cement render which has been damaged in the fire; The late 19th/early 20th century cast iron rainwater goods are in reasonably good condition.

Fig 7: Front (L) and north (R) Existing elevation, historic fabric in yellow, modern in green

The elements of particular architectural heritage interest which do remain, apart from the masonry structure itself, are the fine stone entrance stairs and associated iron railings, these were not damaged by the recent fire. The historic stone steps have been screeded over with a thin layer of cement

concrete. The architrave to the formal entrance door, with its expressed flanking pilasters and fanlight is still intact and, together with the entrance stairs, gives this relatively modest house a formal dignity even in its current dilapidated state.

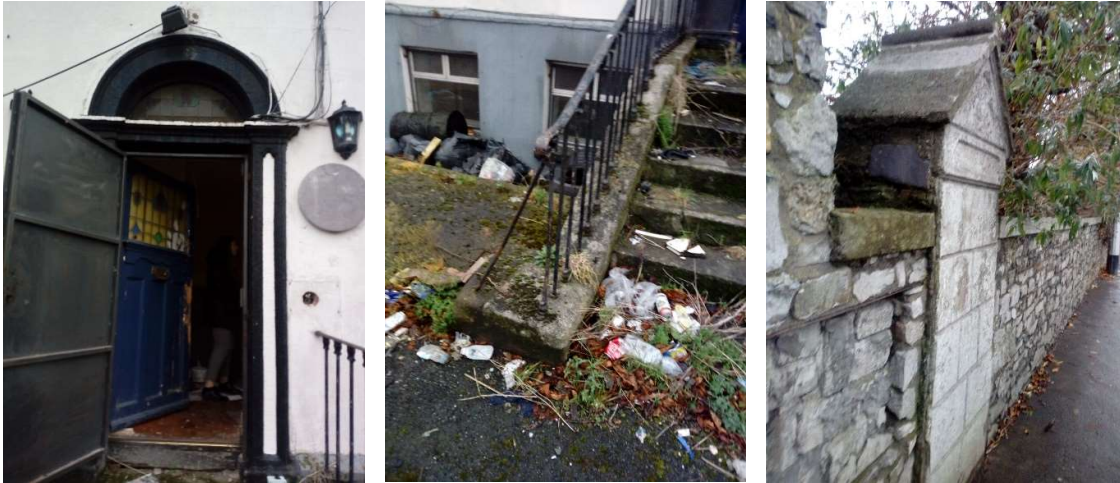
Fig 8: Contemporary Views of the Exterior: Entrance Door (L), Entrance Steps (M), rendered masonry block post to northern boundary wall (R)

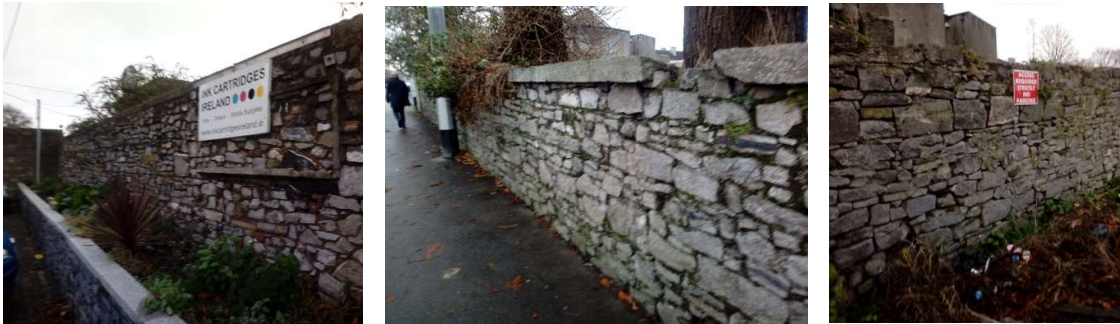
The existing curtilage is considerably degraded but sections of historic rubble stone walls have been retained as have a row of trees to the public road boundary. The rear of the site has been occupied by a warren of storage and light industrial sheds.

Fig 9: Contemporary Views of random rubble stone boundary walls

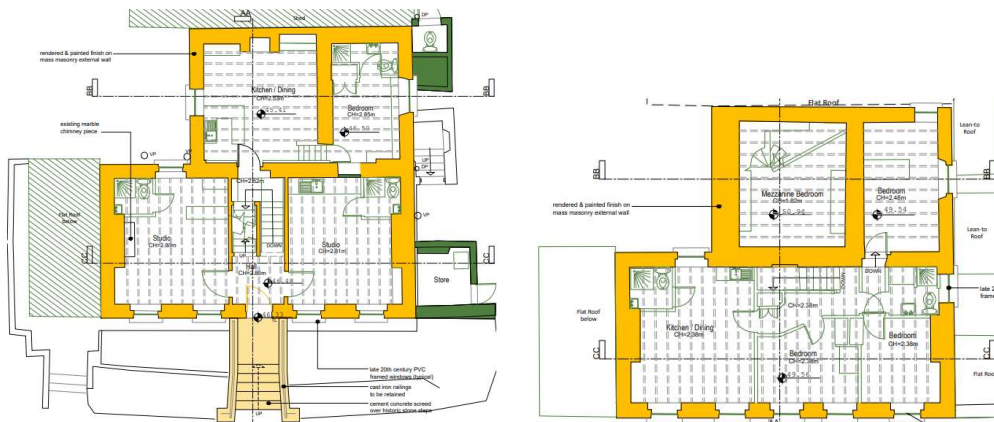
Fig 10: Entrance Floor (L) and 1st Floor (R, prior to fire), historic fabric in yellow, modern in green

The external envelope of the masonry structure which defines the floor plan is retained. Inspection suggests that little of the historic timber structure is retained and the original roof structure had been totally replaced. Internally there has been extensive, rather poor quality, renovation over the years and

very little of significance remains. The upper floor has been largely destroyed by the fire but all of this destroyed fabric was poor quality, late 20th century. The entrance door and fanlight appear to date from the 1930's or 40's, there is a 19th century fire piece and a number of the simple 18th century architraves. As indicated in diagrams above, other than these few items nothing of significance survives although it is possible that some of the original timber stair has been retained within the current configuration.

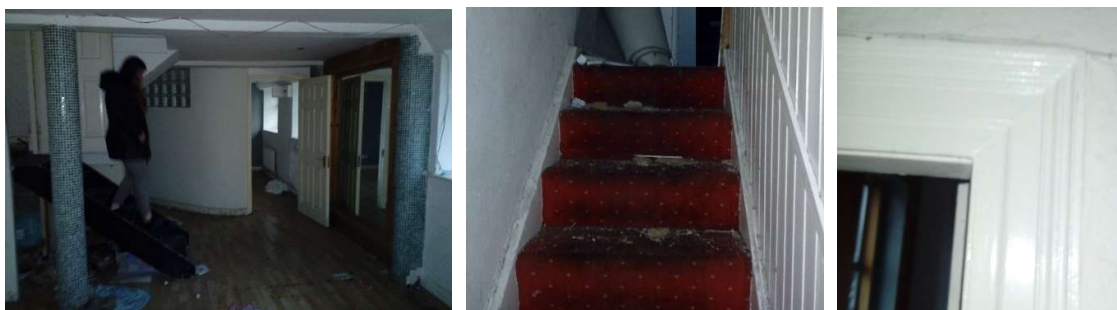
Fig 11: Views of the Interior; Basement (L), Stair (M), Timber architrave in entrance hall (R)

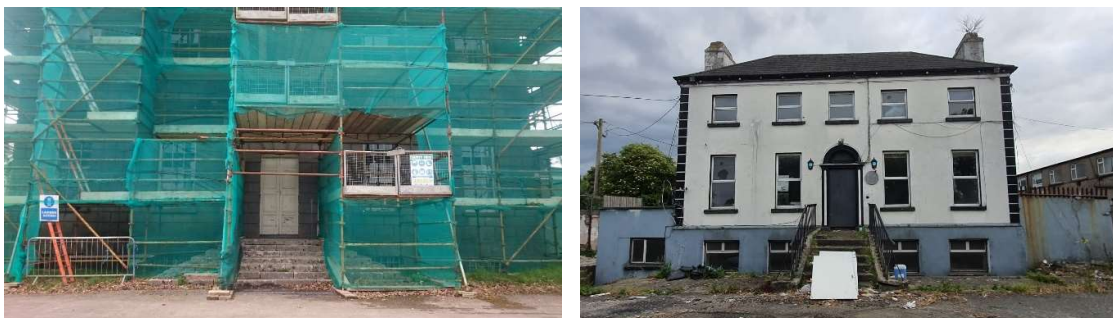
Fig.30: Protective wrapping to scaffolding at Dowth Hall (L), Front façade of Glebe house (R)

Temporary scaffolding will be shrink-wrapped during works to protect the existing facade for the duration of the works. The historic boundary walls will in turn be protected from potential damage caused by this temporary scaffolding by prohibiting penetrations to the historic fabric. All scaffolding will be designed before the commencement of works to ensure that access is provided without risk to the existing building. Where possible scaffold shall be freestanding however should contact with the existing building be required the structure will be protected at through the use of plywood at the point of contact. Existing fabric will inevitably be exposed to high impact and potentially damaging construction phases of the project. Vulnerable features will be physically isolated from construction operations by means of protective barriers and coverings. Such surfaces as flooring, walls up to approximately 2m height, and special construction such as the existing staircase, etc. Existing floor boards will be protected from potential damage caused by abrasion, falling objects, dust and dirt, and spilled liquids. Protective coverings such as canvas tarps or resilient wood fibre panels will be fitted. Canvas tarps will overlap and be taped at all joints. Resilient wood fibre panels will be carefully fitted with tight seams and laid continuously wall to wall. Joints will be taped to avoid displacement of the panels after setting. No temporary protection to heritage finishes will be fixed with screws, nails, adhesives or the like. Temporary doors will also be introduced to control the passage of workers and the inevitable dust and dirt. Accidental damage or loss of original fabric can occur while works to the existing roofs are being carried out. To mitigate this risk safety nets will be provided to slate and other materials falling or sliding. Salvaged slates will be stored in robust containers to minimise handling, storage and breakage. *Vibration:* The construction site will be arranged and planned so that heavy traffic and deliveries associated with demolitions and construction in general access the site as far from the historic structures as is possible. Once construction is under way, continual crack and vibration monitoring will provide an effective warning system, indicating if safe thresholds have been crossed.

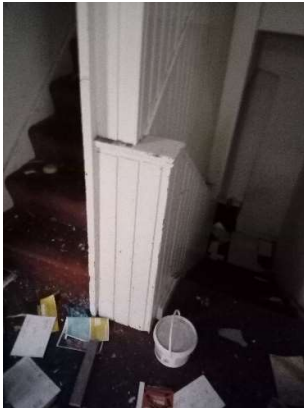
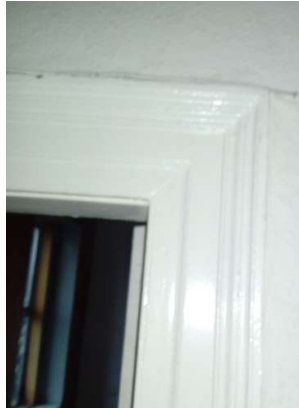
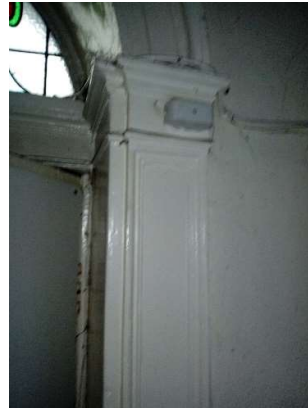
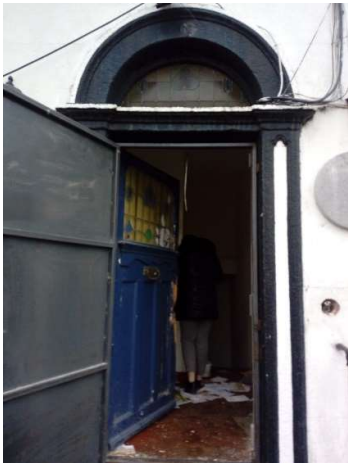
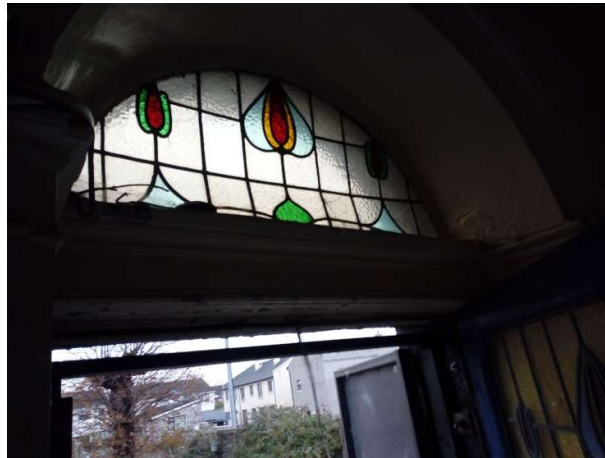
Fig.34: Retained historic joinery at Glebe House

As noted above, very little of the internal historic fixtures remain other than the floor timbers. What remains is shown above; three 18/19th century timber architraves in the entrance/stair hall; a timber front door with glazed panel and fanlight to match, probably 1930's or 40's; None of the existing stairs is historic. The flights are divided by a timber sheeted partition.

A lot of the timber on the 1st floor was damaged in the recent fire. All of this timber work was late 20th century. The following works will be carried to this modern, fire damaged timber fabric;

- Fire damaged studs at first floor level are to be demolished and replaced.
- Stair flight from upper ground to first floor level is to be replaced.
- Floorboards at first floor level are to be replaced.
- Floor joists to kitchen/dining area in the return are to be replaced.

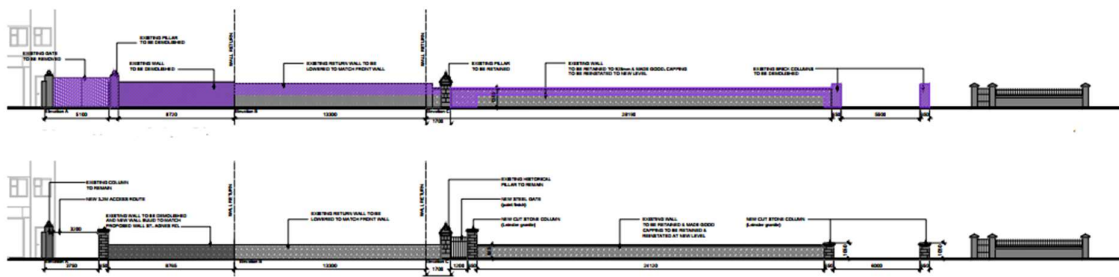
Fig.37: Extract from Architect's Drawing No. P19171D-210 showing proposed works to Boundary wall on St Agnes' Road.

We note that the pillar shown above in *Fig. 37* is not dressed stone but rather masonry rather crudely faced with a cement render dressed to look like ashlar.

The other historic stone features on the site are the extensive sections of random rubble stonewalling to the site boundaries. These walls are to be retained except for small section on St Agnes' Rd as shown in purple hatch in Fig.37 below. The adjacent section of wall on St Agnes' Road is to be lowered by 335mm. The new replacement wall on St Agnes' Rd location will be constructed by skilled masons, under supervision of Conservation Architect, using existing historic stone. All details, coursing dimensions, etc. will match existing. The retained walls will be well washed to remove any dust and friable material, making sure that the entire elevation is cleaned down to prevent staining. The backing mortar will be kept damp to prevent a too rapid drying, resulting in cracking. Joints will be raked back to approximately 25mm, thoroughly cleaned including top and bottom faces of the beds. Existing mortar will not be removed with inappropriate mechanical cutters, such as angle grinders. Pinning Stones will not be removed, but if they are loose, they will be removed and put back during repointing. Where the original pinning stones have been lost, suitable replacements will be used. We will use a NHL 3.5 Lime based mortar. Sound existing pointing will be left undisturbed. Care will be taken to preserve the original pattern of work.
