Glebe House, Crumlin Village, Crumlin, Dublin 12

Preliminary Demolition, Construction & Waste Management Plan

Project No: 1968

Issue No.8

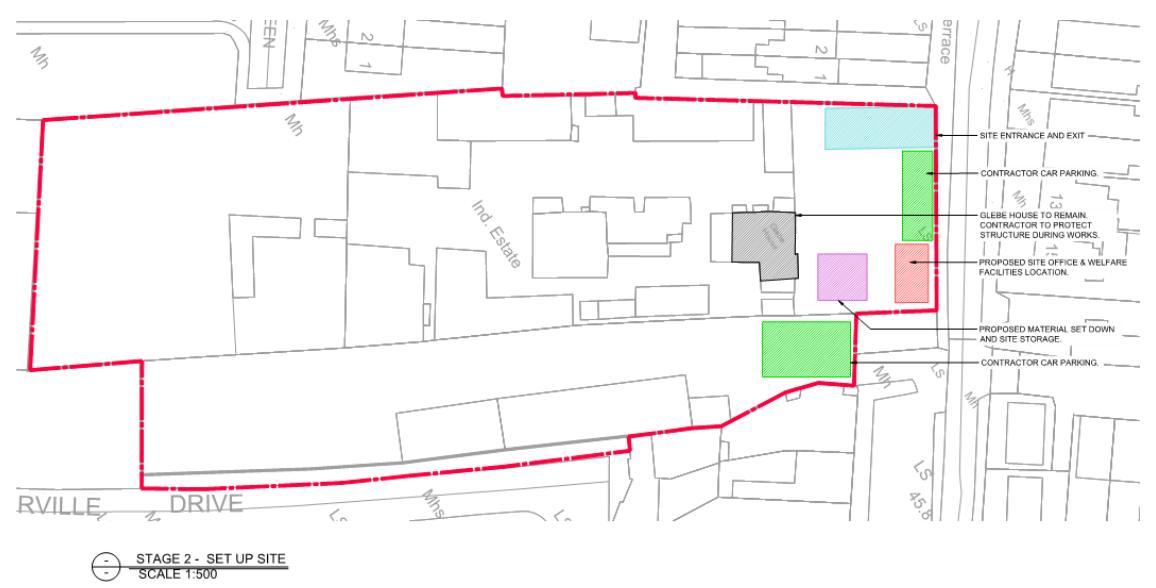
Figure 2: Site Set Up

A site office will be established on site to provide adequate welfare facilities for the site operatives, storage of relevant site documents and location for on-site meetings. The location of the site office will be confirmed by Main Contractor at the time of works. An indicative site set up is shown in Figure 2 and it is proposed to situate the offices at the North (front) of the site. The proposed site set up area is indicated on CORA drawing C.030.

Suitable areas for the storage of construction material will be determined at the time of works. The storage of materials will not impede access or egress to the works and will be kept separate from boundary walls and temporary hoarding to ensure no excess loading to these elements. Parking will be provided to the front of the site for Contractor personnel.

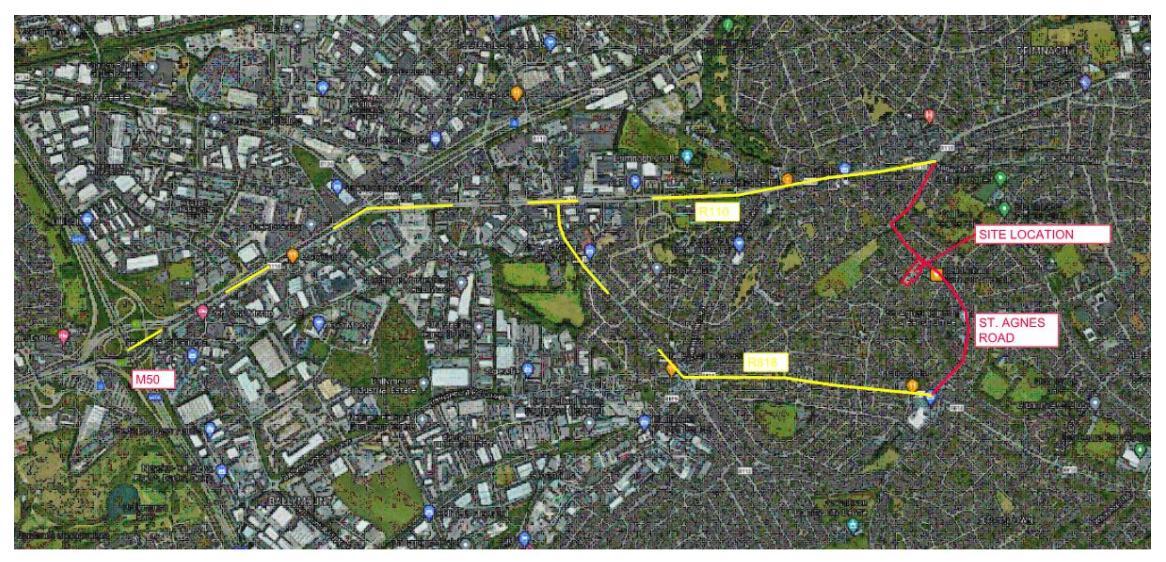
Figure 3: Suggested Traffic Approach to Site Regional

Figure 3 below shows the proposed approach and exit road to the site on a regional scale. Figure outlines the local approach and exit along St. Agnes Road.

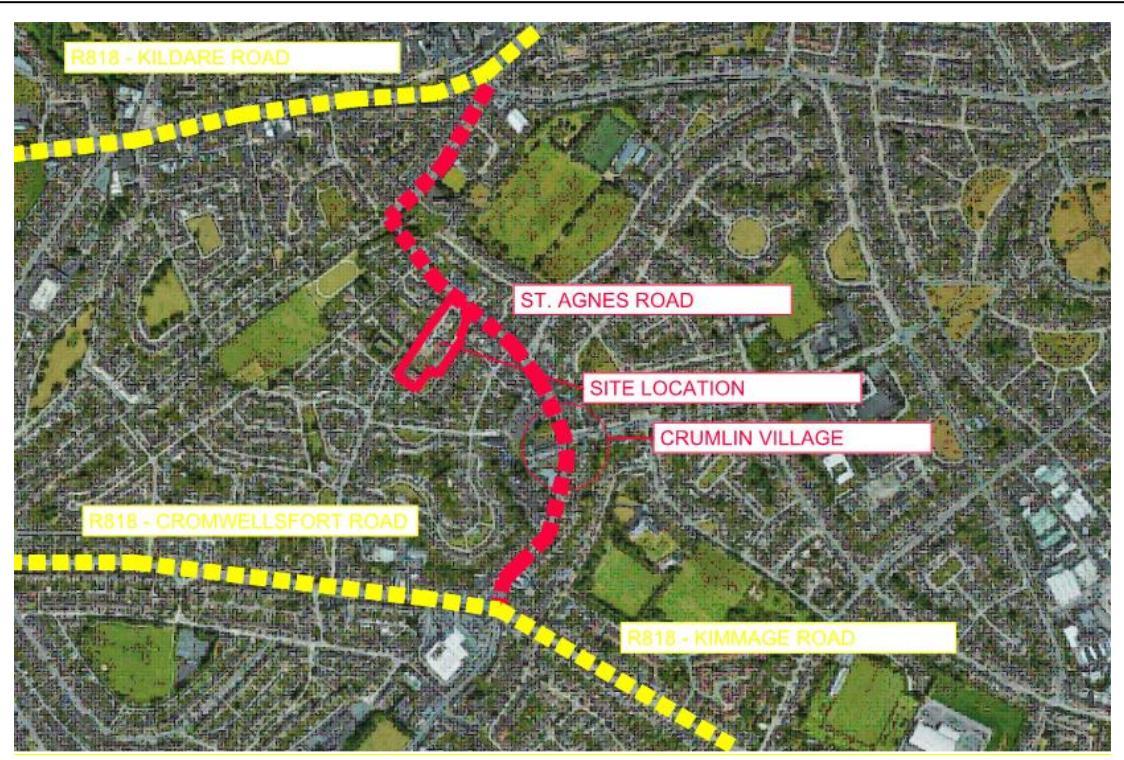
Figure 4: Suggested Traffic Approach to Site Local

For heavy goods vehicles such as articulated trucks etc, it is proposed that these vehicles will enter the site travelling south along St. Agnes Road and will exit via north via St Agnes Road. Details of the swept path analysis are shown on CORA drawing C.034.

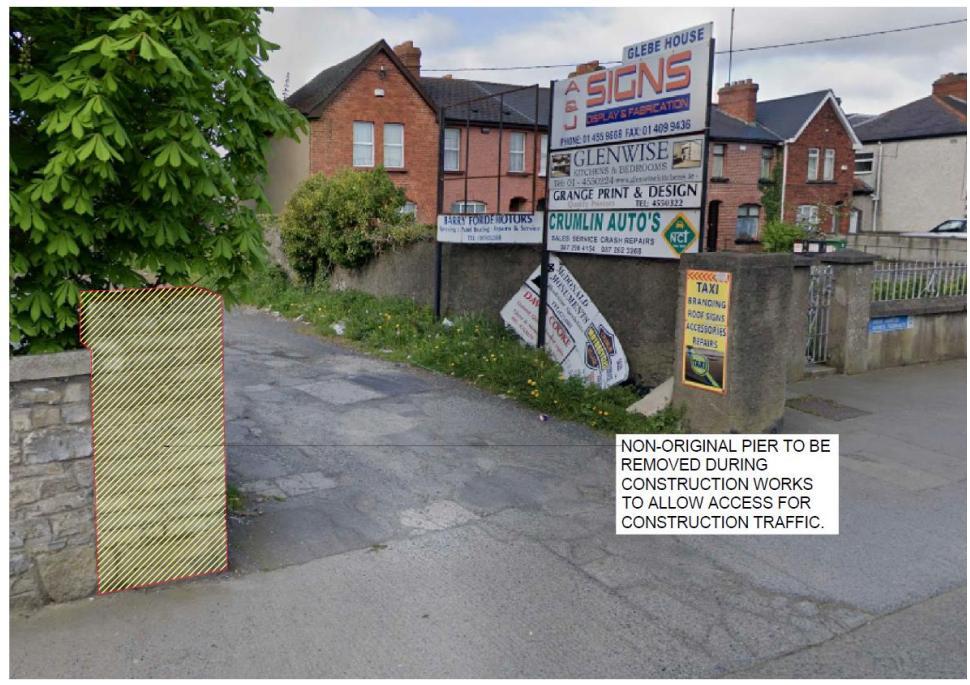
Figure 5: Works to gate to facilitate access

As identified above construction access to the site will be through the existing access at St. Agnes Road. In order to facilitate the entry of vehicles form the East, it will be necessary to remove the existing gate pillar to widen the entrance for larger construction vehicles and plant. The pillar is non-original block and is shown in Figure 6 below. During this process, particular care is to be given to the remaining stone wall fronting onto St. Agnes Road which is to remain as part of the curtilage of Glebe House. Protective hoarding will be erected around the wall and temporary support provided to the gated end until installation of the permeant entrance finish.

Further auto-track analysis has been undertaken to show sufficient access and egress to the site. This is shown on CORA drawing C.032. The analysis has been expanded to show possible site movements for the outline construction sequencing. These are shown in CORA drawings C.033 and C.034. The drawings show that suitable vehicular paths can be maintained around the site while construction progresses.

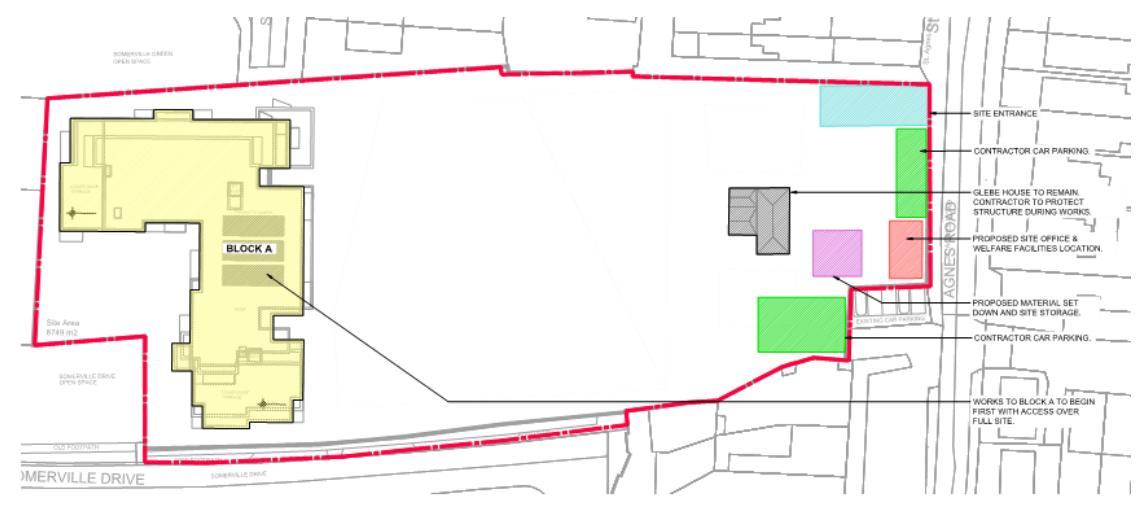
Figure 6: Outline Construction Stage 3 - Block A

Apartment Block A to the rear/South of the site is the furthest from the entrance on St. Agnes Road and is to be started first. Once foundations have been completed, the contractor will move to Apartment Block B to commence foundation work while works to the Block A superstructure begin.

- Excavation for foundations.
- Construction of in-situ reinforced concrete footings.
- Construction of solid block rising walls, concrete stair cores and structural concrete columns
- Installation of drainage pop-ups, sub grade and construction of reinforced ground floor slab.
- Construction of concrete structural beams at first floor level
- Installation of first floor precast structural elements.
- Similar sequencing to remaining floors and installation of roof.
- Installation of external envelope and exterior finishes.
- Mechanical and electrical fit out.
- Completion of Finishes
- Commissioning and testing of plant.
- Completion of drainage and landscape works.

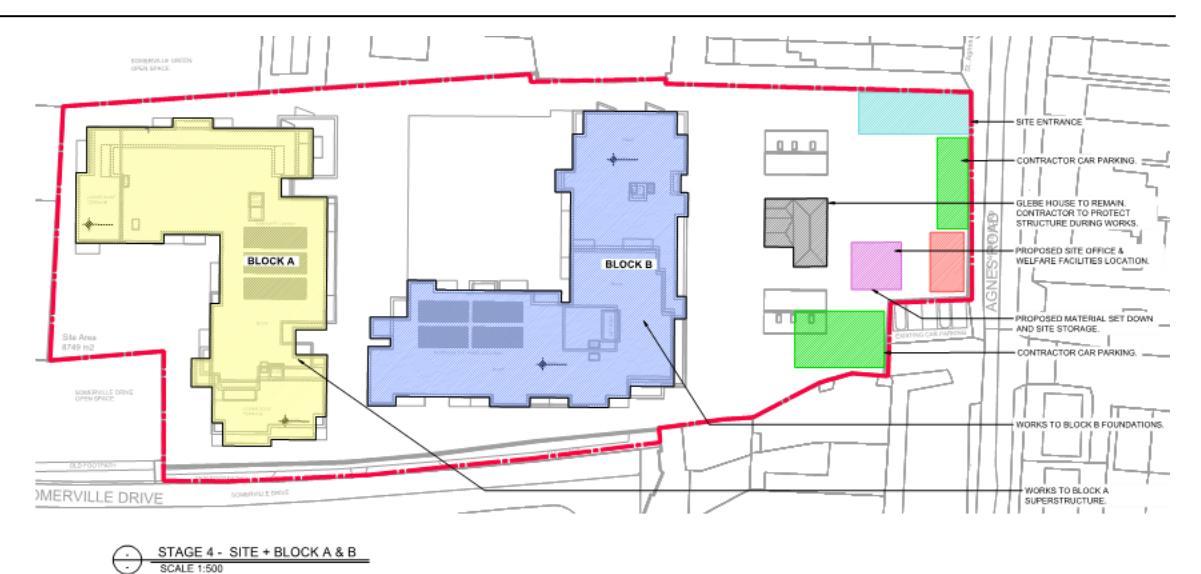
Figure 7: Outline Construction Stage 2 – Block B

The above methodology will be repeated for Block B. The podium structure will not be completed until further into the project timeline. This allows for the area to be used for site traffic and material set down. Refer to CORA drawing C.030 & C.031 for site sequencing.

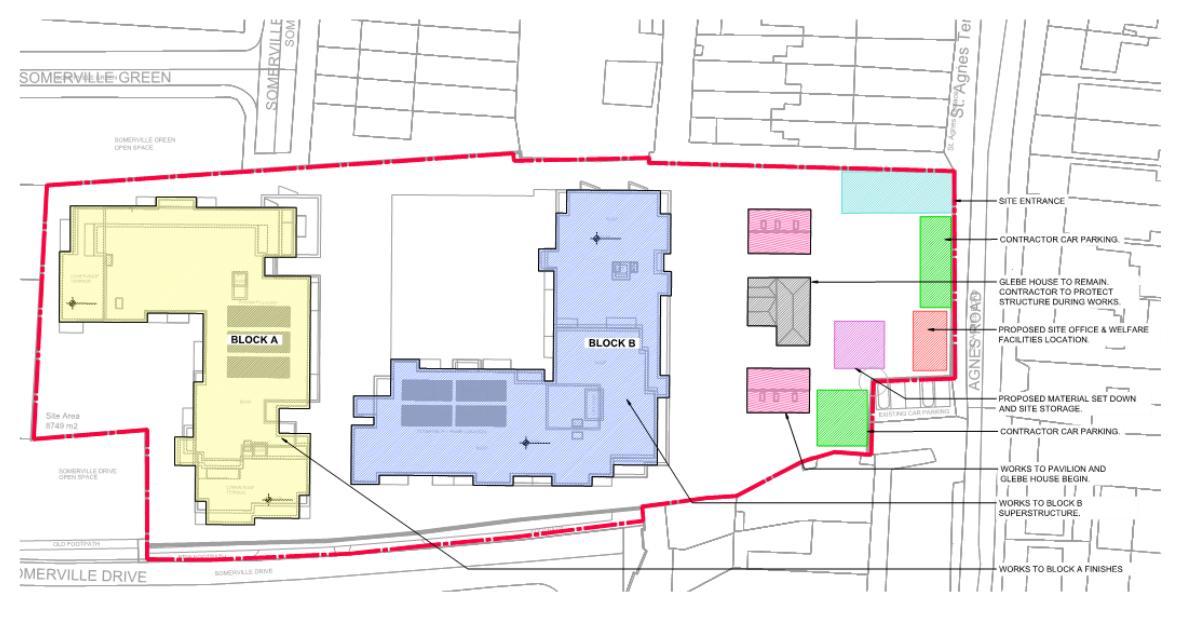
Figure 8: Outline Construction Stage 3 – Pavilion Buildings & Glebe House

Glebe House is to be refurbished and converted for residential use. The further two pavilion buildings will be constructed last as the area adjacent to glebe house will be used for the site compound, site traffic and material set down. Refer to CORA drawing C.030 & C.031 for site sequencing. For the duration of the works, protective hoarding and fencing will be erected around Glebe House to provide protection.

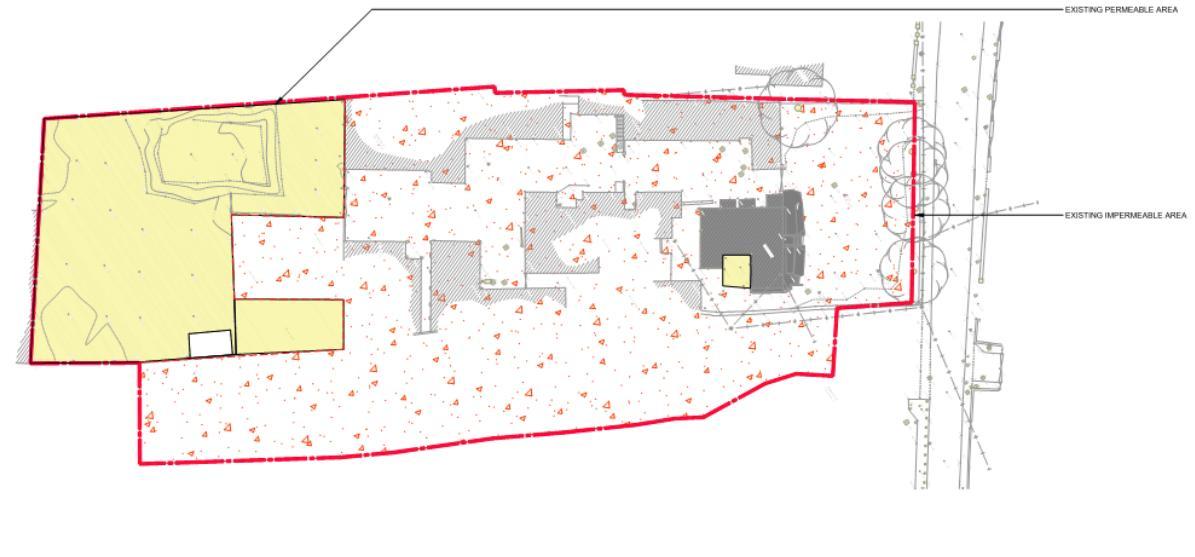
Figure 9: Existing Site Survey

EXISTING SITE AREA TYPES

The existing concrete slab will have to be broken out and removed from site. The existing concrete area is approximately 6600m². Allowing for a 200mm thick slab, it is anticipated that the slab will generate approximately 1320m³ of concrete to be demolished and removed.

The existing industrial buildings will be demolished and removed from site. The cumulative area of the buildings is 2,158m² resulting in approximately 3,235 tonnes of construction waste. The units are constructed from concrete block light structural steel and timber.
